Aircraft Accident Investigation Bureau

Interim Investigation Report on

**Accident to the B737-8 (MAX) Registered ET-AVJ operated by
Ethiopian Airlines**

Report No. AI-01/19

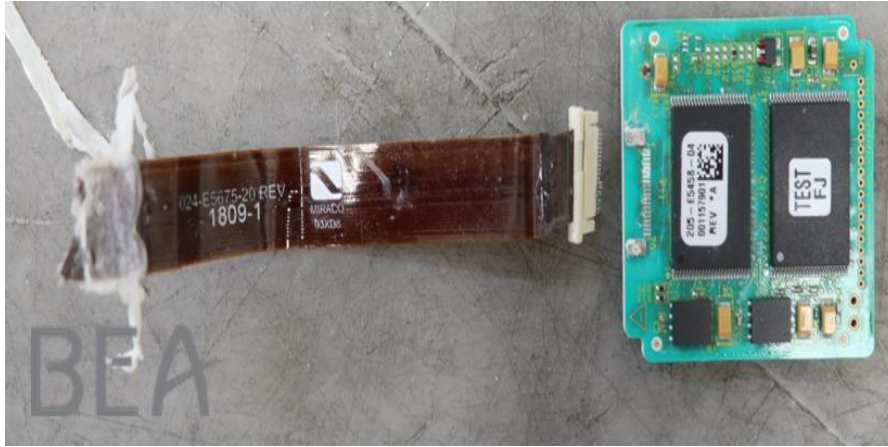
FIGURE26 : FDR MEMORY BOARD, FLEX AND CONNECTOR

The memory board was visually inspected with a Keyence microscope. Apart from the connector pads, the memory board was in good condition. There was no trace of impact. The two memory chips as well as the micro-processor were found in good condition.

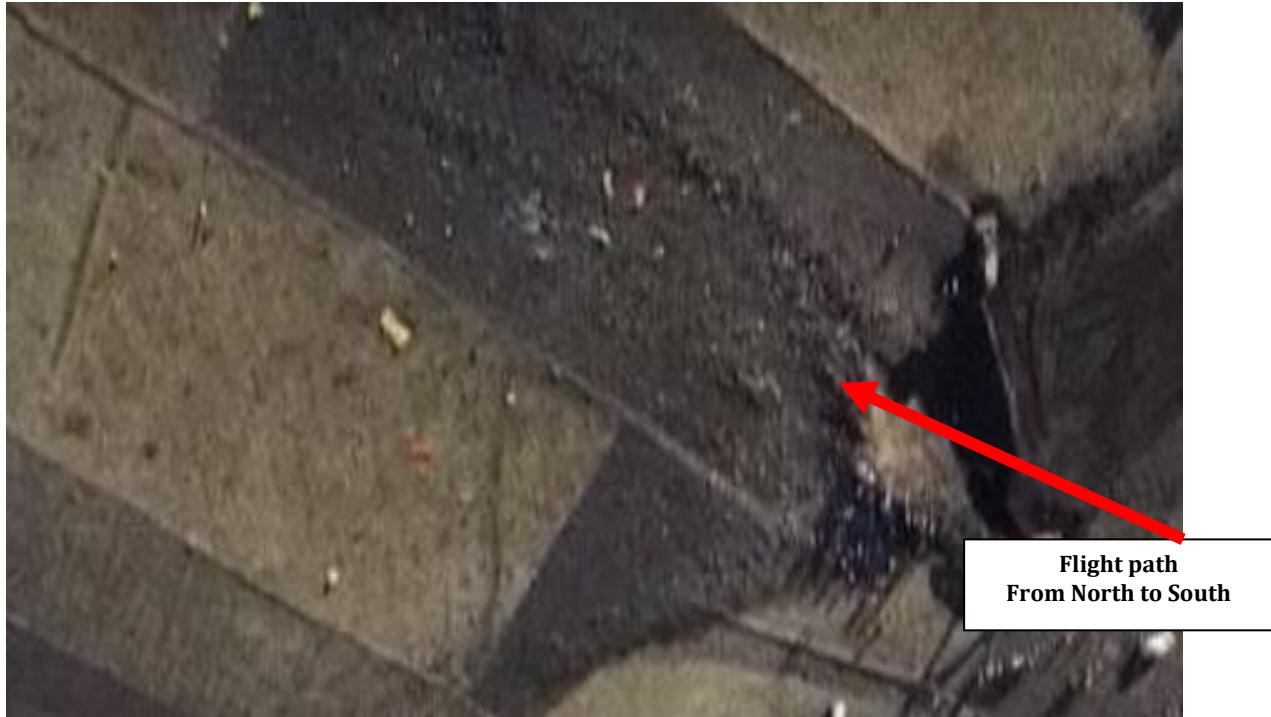
FIGURE 32: TOP VIEW OF THE CRATER

scattered around the site in an area by about 200 meters width and 300 meters long. The damages to the aircraft are consistent with a high energy impact.

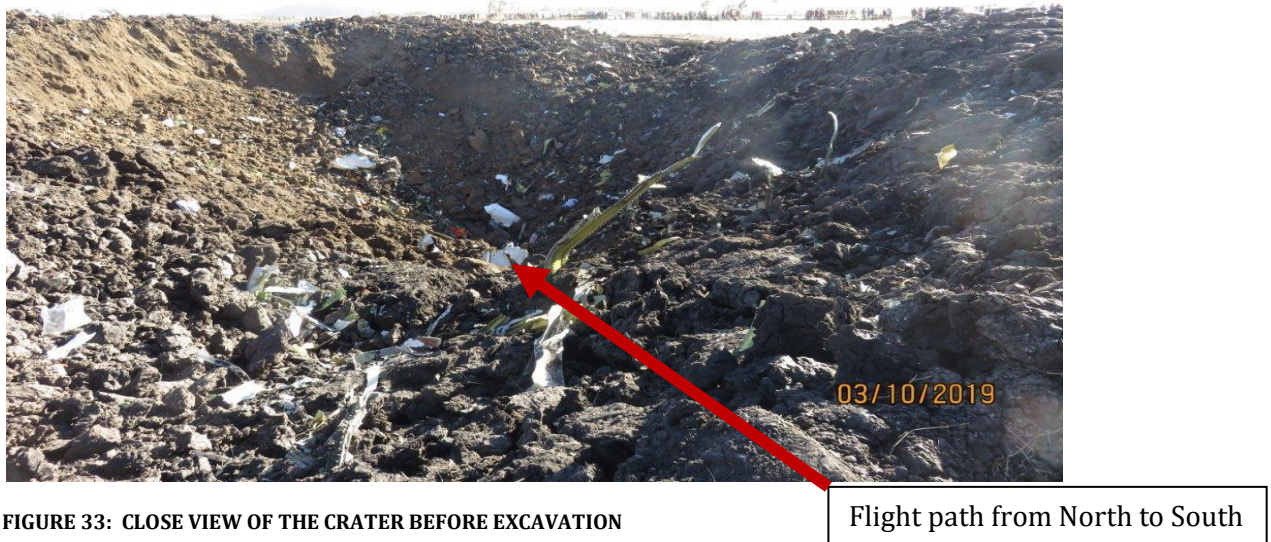
FIGURE 33: CLOSE VIEW OF THE CRATER BEFORE EXCAVATION

At 05: 44 :The Aircraft impacted terrain 28 NM South East of Addis Ababa near Ejere(located 8.8770 N, 39.2516 E.) village at a farm field and created a crater approximately 10 meters deep (last aircraft part found) with a hole of about 28 meters width and 40 meters length. Most of the wreckage was found buried in the ground; small fragments of the aircraft were found scattered around the site in an area by about 200 meters width and 300 meters long. The damages to the aircraft are consistent with a high energy impact.

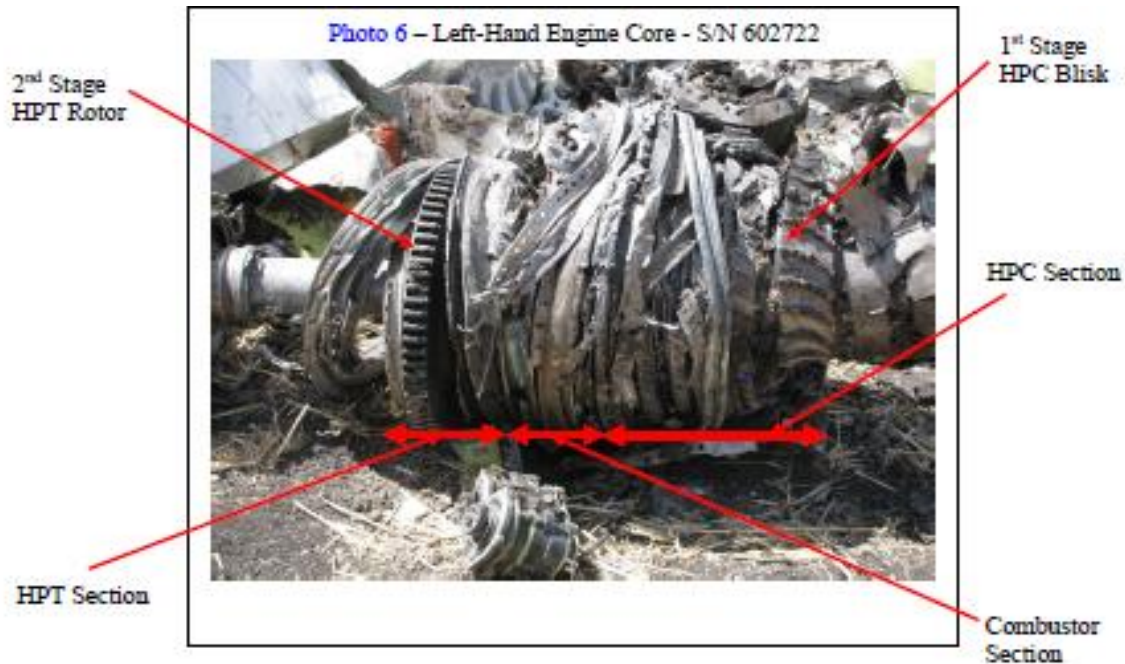
FIGURE 35 : LEFT HAND ENGINE SECTION

The left engine core was recovered from the site and examined by the group. The engine was reportedly recovered at a depth of approximately 10 to 15 meters depth on the left side of the excavation site. The predominant feature of the deformation of the entire remaining core was axial deformation.

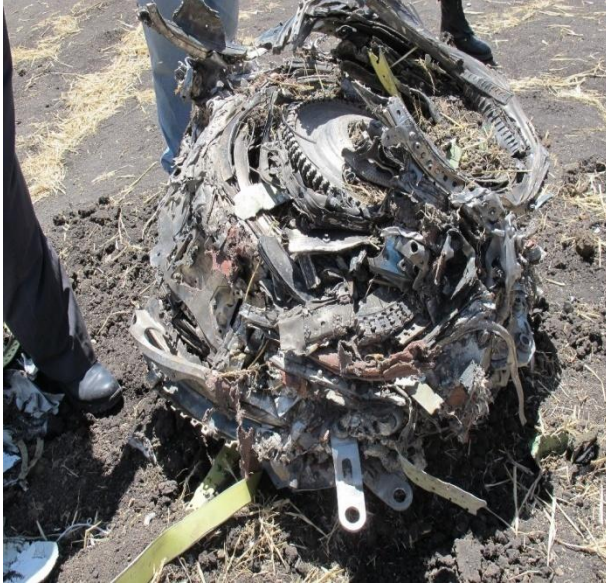
FIGURE 36: R/H ENGINE - S/N 602695 - CORE

The predominant feature of the deformation of the entire remaining core was axial deformation.

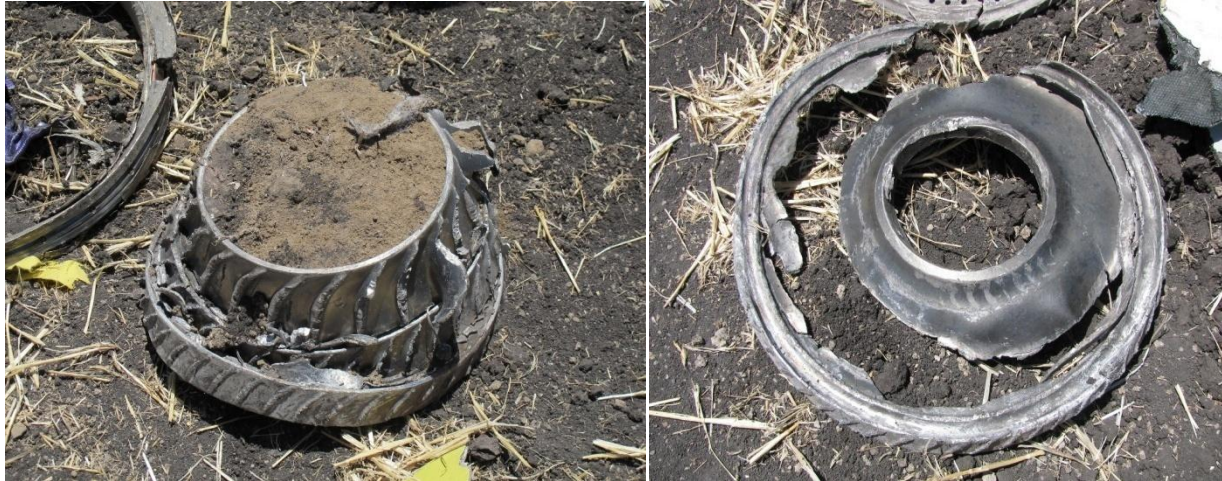
FIGURE 40: - R/H ENGINE - S/N 602695 – HPC STAGES 1 TO 3 FIGURES 41:- R/H ENGINE - S/N 602695 – HPC STAGE 7

The HPC case was fractured and a portion of it remained with the core and the HPC stages were separated from the core. The 1st, 2nd and 3rd stage blisks were found together and were missing their airfoils. The 4th, 6th, and the 8th to 10th stages were not found. The 5th stage was found separately, and it was also missing its airfoils. The 7th stage web was fractured circumferentially. The stator sections could not be identified.

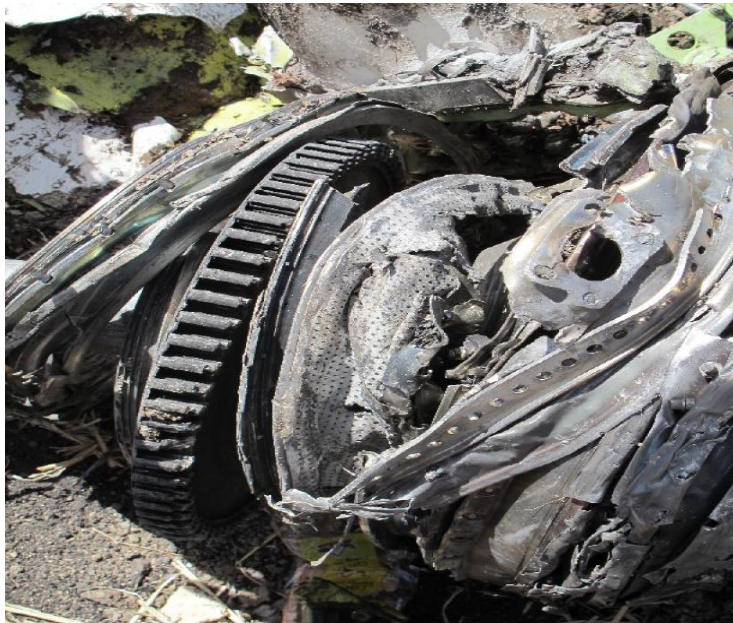
FIGURE 42 : COMBUSTOR CRASHED

The combustor was severely crushed and most of it was missing into pieces.

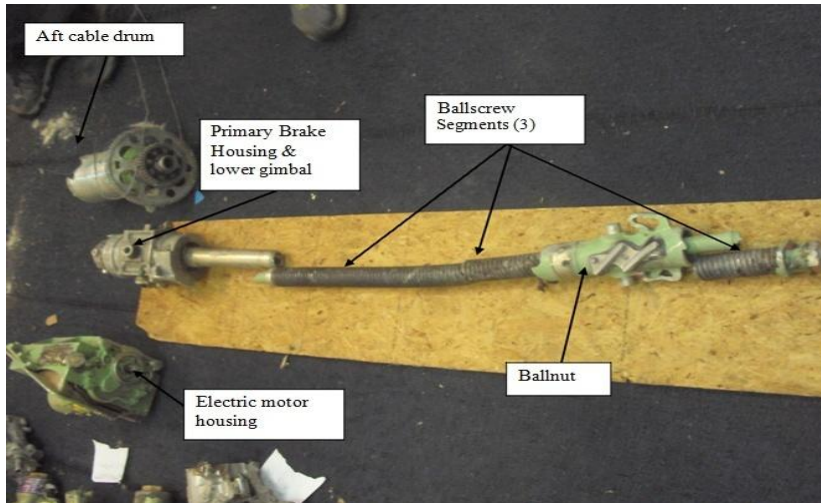
Figure52 : recovered Stabilizer Trim components

The figure below shows the relationship of the ballnut position along the ball screw. There is a safety rod which acts as a secondary load path should the ball screw fracture in service for any reason. It is attached to a separate set of secondary gimbals below the primary support gimbals on the primary brake housing and to the top of the ball screw. Figure 54 shows the safety rod and that it protrudes out from the ball nut. However, the fracture faces on the 5" long upper screw portion (note the measurement in Figure 53) match those found near the ballnut upper stop. This is consistent with the safety rod being pulled out several inches prior to final fracture.
