Aircraft Accident Investigation Bureau

Interim Investigation Report on

**Accident to the B737-8 (MAX) Registered ET-AVJ operated by
Ethiopian Airlines**

Report No. AI-01/19

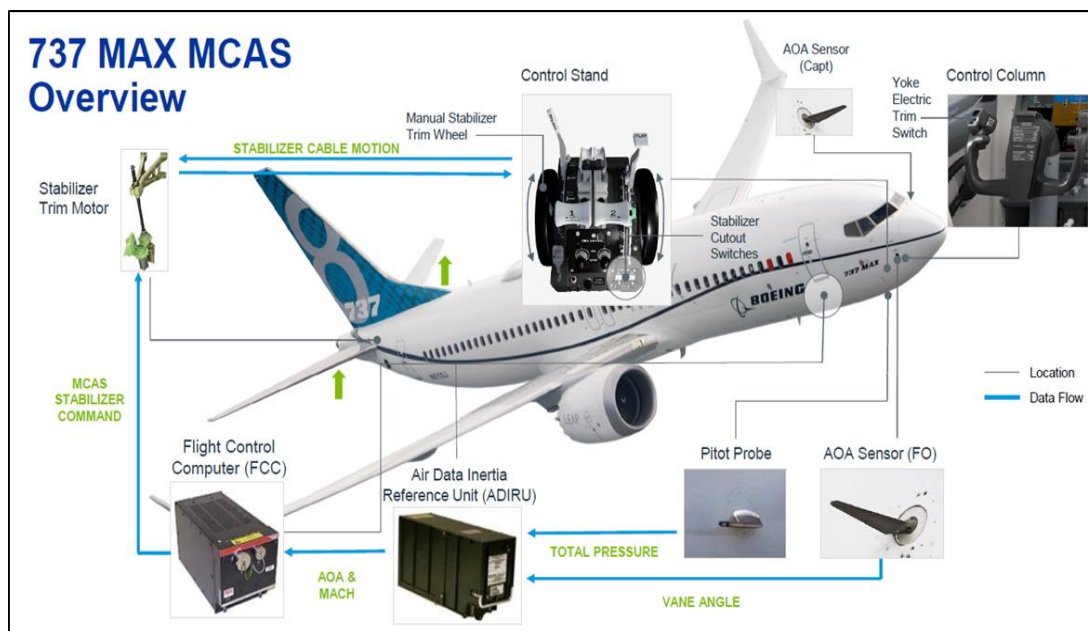
FIGURE 13: DIAGRAM SHOWING THE COMPONENTS OF MCAS¹¹

The MCAS is a function within the Speed Trim System and, when activated, moves the stabilizer during non-normal flaps up, manual flight, high angle of attack maneuvers to provide a desirable increase in stick force gradient and a reduced pitch up tendency. Similar to the Speed Trim function, the MCAS function is also a flight control law¹⁰ contained within each of the two FCCs. MCAS is only active in the master FCC for that flight. At airplane power-up, the master FCC defaults to the left side FCC; and will then alternate between the left and right FCC by flight. The master FCC is not affected by the position of the Flight Director switches. The FCCs receive inputs from several systems including the Air Data Inertial Reference specific to the MCAS, the control law commands the stabilizer trim as a function of the following: air/ground signal, flap position, angle of attack, pitch rate, true airspeed and Mach.

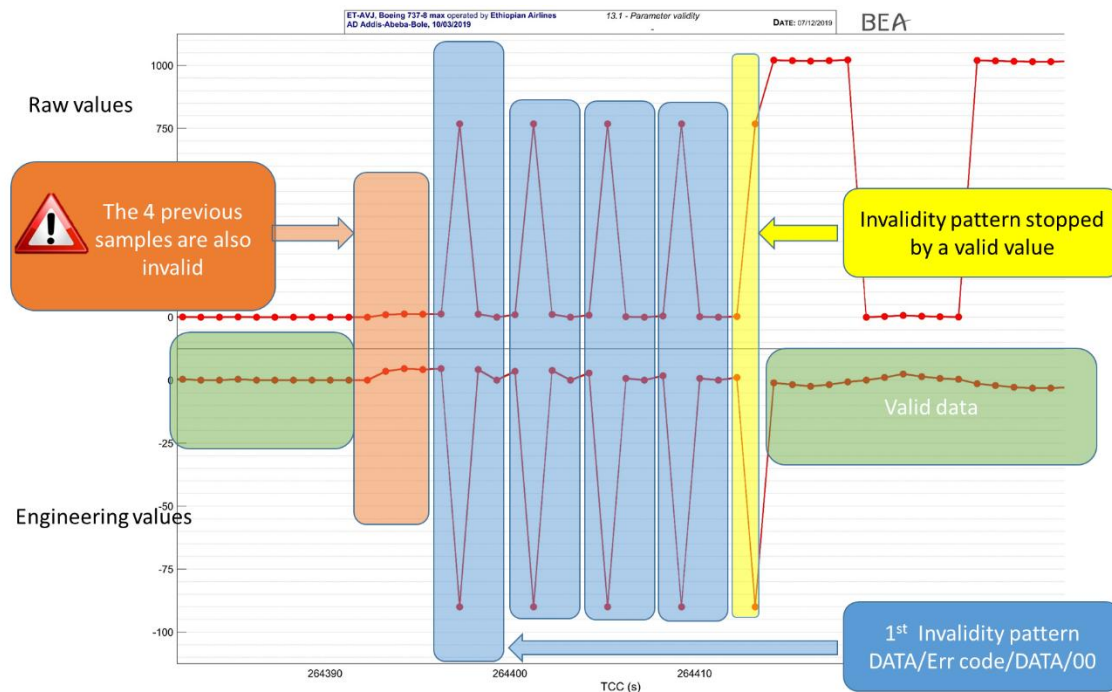
FIGURE27: ILLUSTRATION OF THE INVALIDITY RECORDING

Indeed, the FDAU would transmit in this case: 4 samples of data as if they were valid, then the invalidity pattern starting with the data and then only the error code (the 6th values recorded after the start of the invalidity). For a parameter recorded each second, up to 6 s of invalidity may not provide any cue inside the recorded data.

These impacts are illustrated in the Fig 27 with the same parameter plotted twice (raw recorded values on the top and engineering values on the bottom).

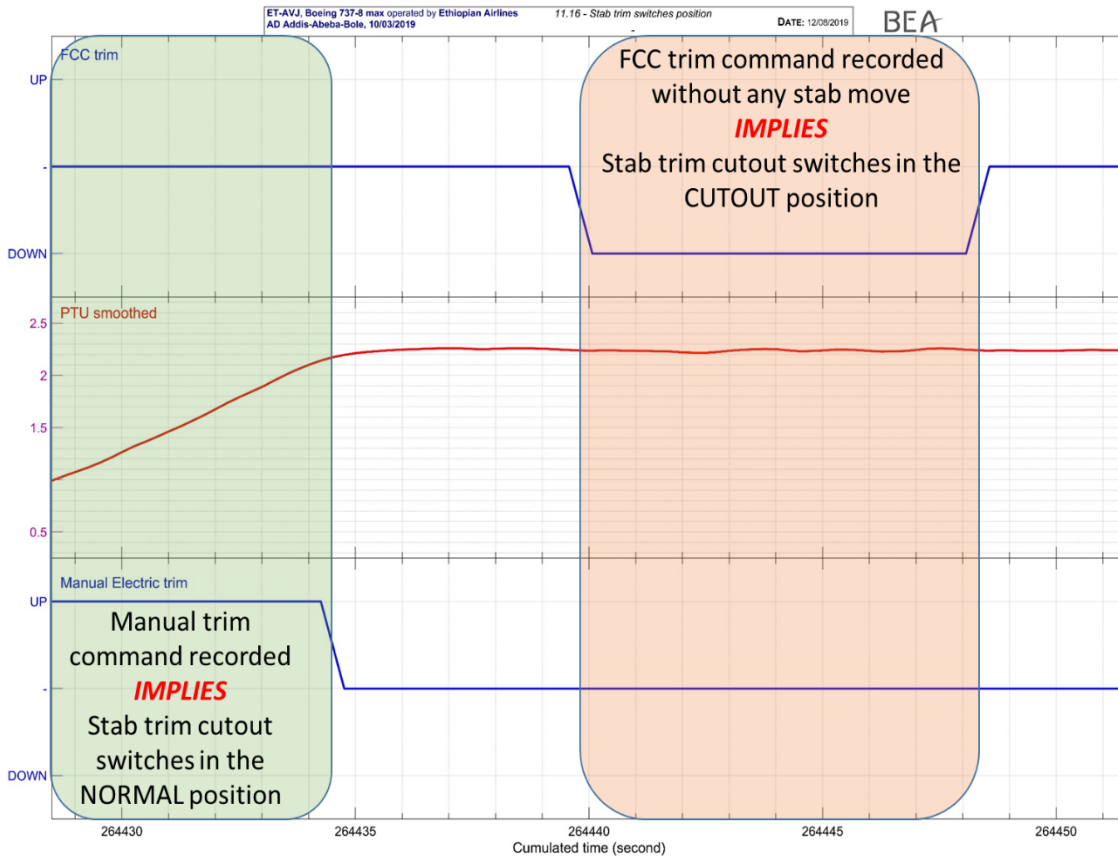
FIGURE 28: STAB TRIM CUTOOUT SWITCHES POSITION

No discrete parameter records the positions of the stab trim cutout switches. However, some recorded parameters provide information on these positions:

- The discrete parameter of the manual electric trim command records command (up or down) only when both stab trim cutout switches are in the normal position.
- The discrete parameter of the FCC trim command records command whatever the positions of the stab trim cutout switches are. When FCC commands are recorded, if no stabilizer motion is recorded, it means that at least one stab trim cutout switch is in the CUTOUT position.

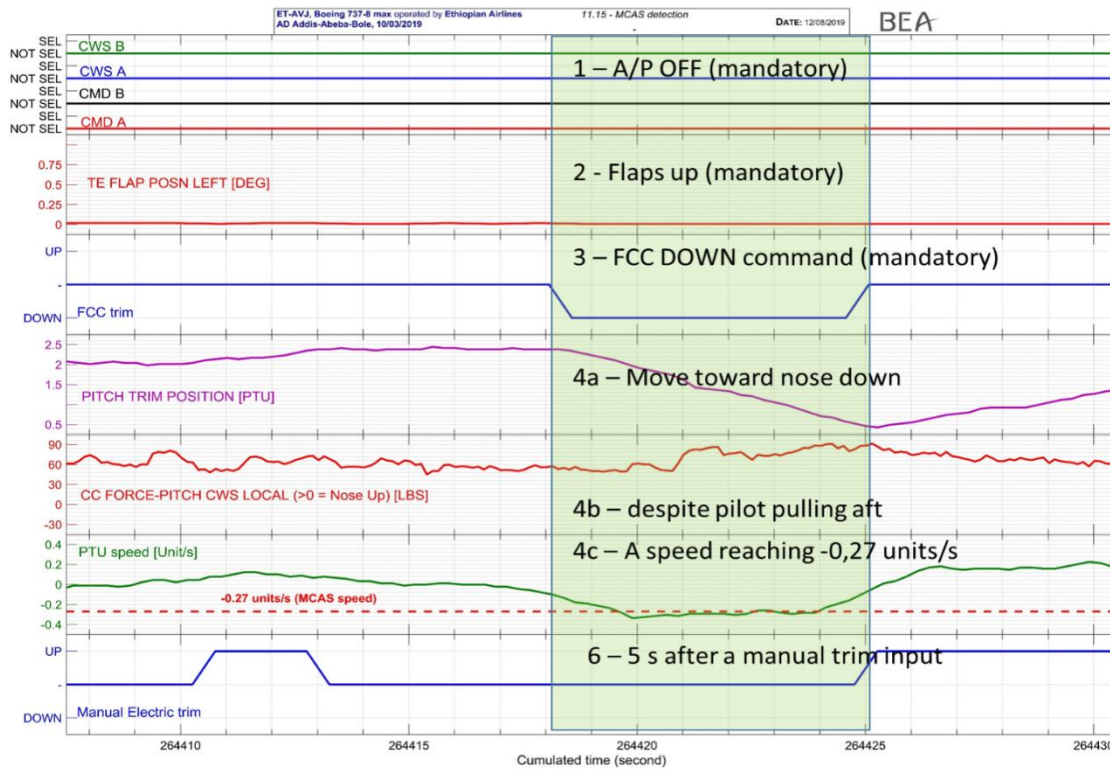
FIGURE 29: MCAS DETECTION WITH FDR DATA

No discrete parameter records the MCAS activation. However, MCAS activation can be detected with the following recorded information:

1. The autopilot is not engaged
2. The flaps are retracted
3. The stabilizer move is commanded by the FCC in the “down” position
4. If stabilizer moves,
 - The stabilizer moves toward aircraft nose down command.
 - This move of the stabilizer, if it is in opposition with the pilot command (pilot pulling aft), is only possible under MCAS activation.
 - The speed of automatic moves of the stabilizer is typically limited when flaps are up. This speed reaches $0.27^\circ/\text{s}$ only under MCAS activation.
5. If stabilizer did not move, the FCC command shall last during a time consistent with the MCAS computed duration.
6. If a manual trim command was performed before, MCAS triggers after a delay of 5 s.

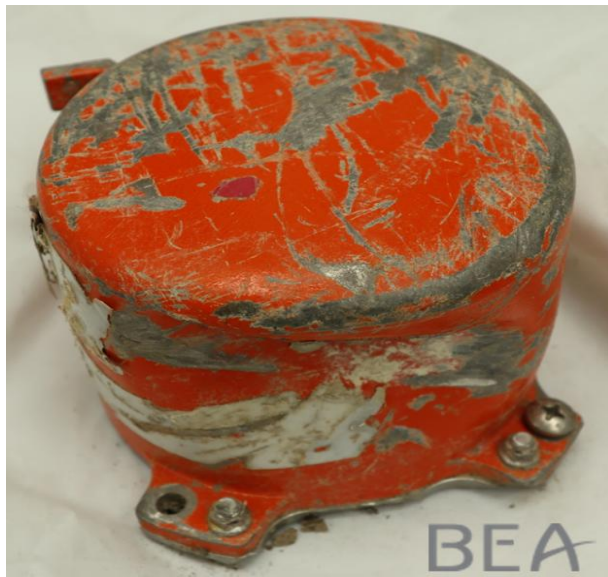
FIGURE 30: CVR CSMU

On 11 March 2019, the CVR was recovered from the accident site by the AIB. The CVR CSMU was transported to the BEA recorder facility for data downloading. The CMSU was found separated from the chassis during wreckage recovery. The read-out was performed by BEA under the authority of the Ethiopian Accident Investigation Bureau (AIB), with the observation of the National Transportation Safety Board (NTSB) of United States of America.

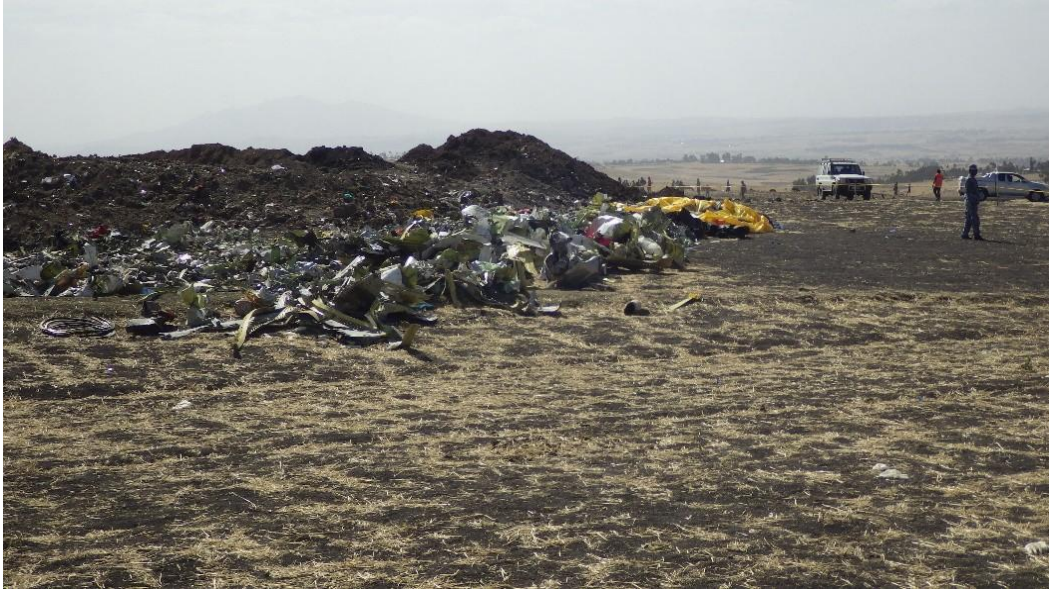
FIGURE 34: ACCIDENT SITE

The Aircraft impacted terrain at a farm field and created a crater approximately 10 meters deep (last aircraft part found) with a hole of about 28 meters width and 40 meters length. Most of the wreckage was found buried in the ground; small fragments of the aircraft were found

scattered around the site in an area by about 200 meters width and 300 meters long. The damages to the aircraft are consistent with a high energy impact.

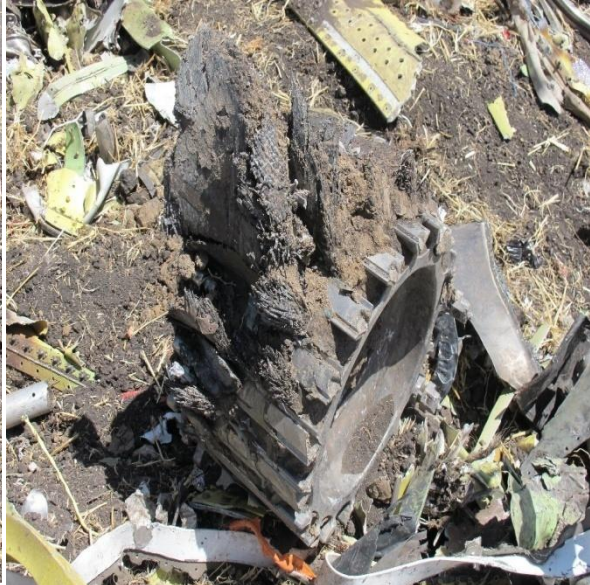
FIGURE 37: - R/H ENGINE - S/N 602695 - FAN DISK

The right engine core was recovered from the site and examined by the group. The recovered core of the right engine was more damaged than the left-hand engine. The engine was reportedly recovered at a depth of approximately 10 to 15 meters depth on the right side of the excavation site.

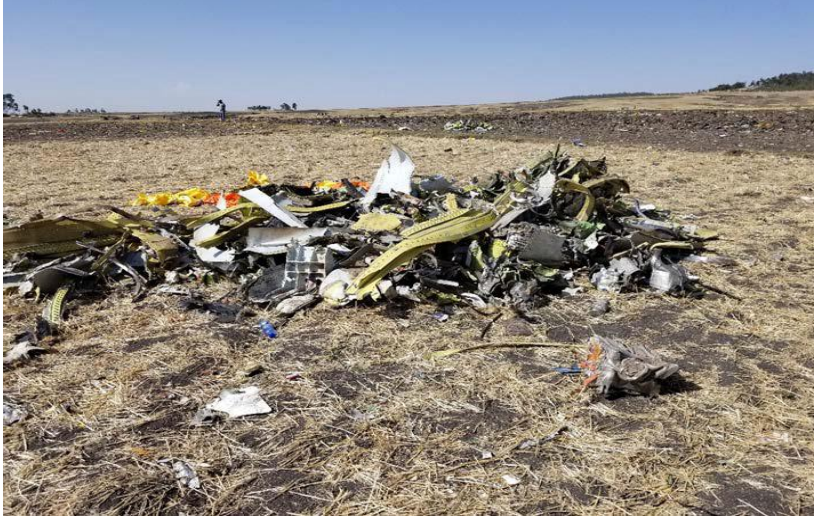
FIGURE 43: RECOVERED WRECKAGE PILE ON THE SITE

The Airworthiness Group, comprised of members from Ethiopian CAA, Boeing, and NTSB convened at accident site, located near Ejere, Ethiopia, on March 12, 2019 to examine the aircraft wreckage with a specific focus on flight controls and the air data system components.

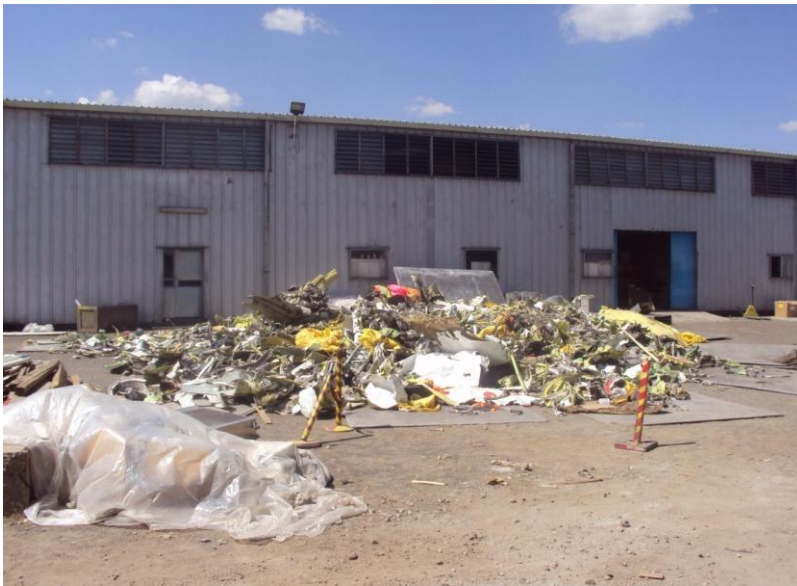
FIGURE 44: RECOVERED WRECKAGE PILE

The investigation team had much of the wreckage moved from the impact site to a secured location on Addis Ababa AIB store. The wreckage pile measures approximately 5' high and about 30' in diameter. Assistance from Ethiopian Airlines recovered a number of flight control components – some are documented above during the on-site examination. Below is a detailed exam of each of the identified components.

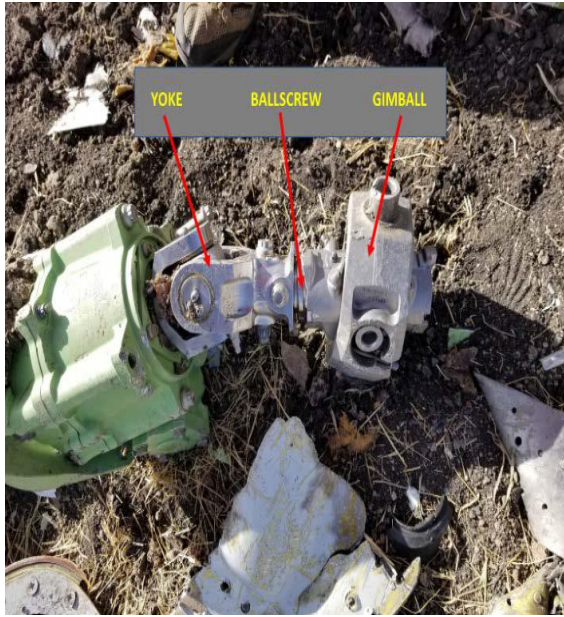
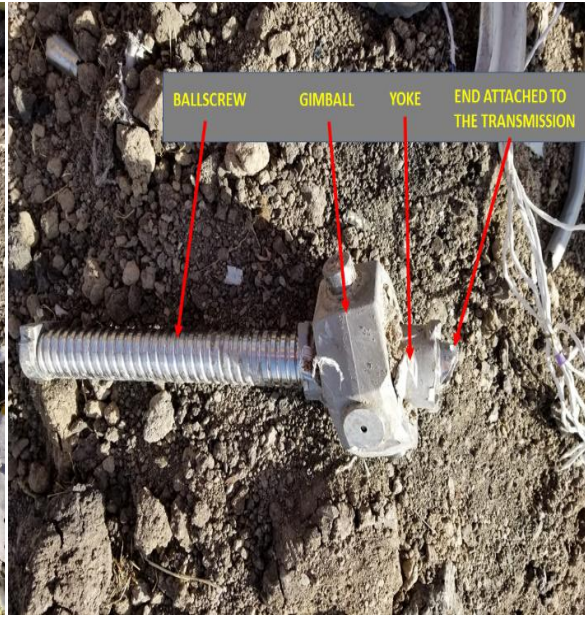
Two parts of the actuation system were located and examined at the impact site. One consists of the ballscrew, yoke, gimbal and flap transmission; the other consists of just the ball screw, yoke, and gimbal (see **Figures** respectively).

The installed location of each unit has not been identified. The position of each gimbal is consistent with the flaps in the fully retracted position.

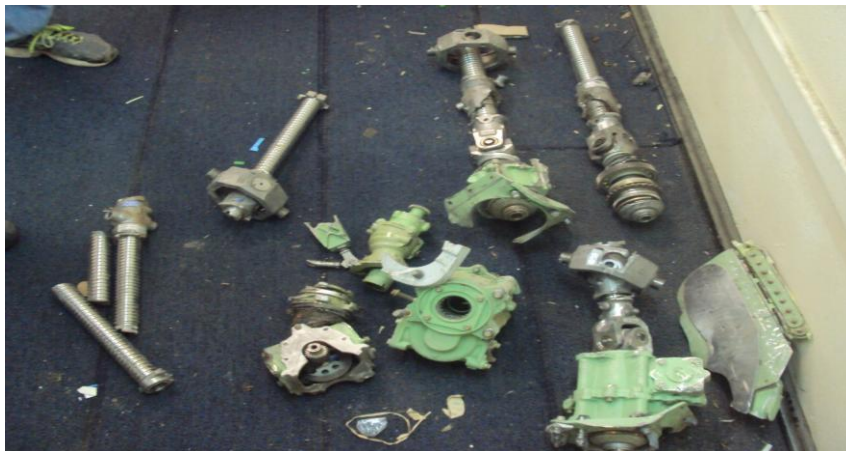
FIGURE47: TRAILING EDGE FLAP TRANSMISSIONS AND BALL SCREWS

During the examination of the wreckage pile located at the Addis Ababa airport AIB store, the Airworthiness group identified a total of 4 (including the ones identified at the impact site) trailing edge flap transmissions (there are 8 total); three of these had the ball nut and gimbal still attached.

Again, all three were found in the fully retracted position. There was one additional transmission portion that was found as well as three ball screw segments. All examined damage appears consistent with high energy impact.

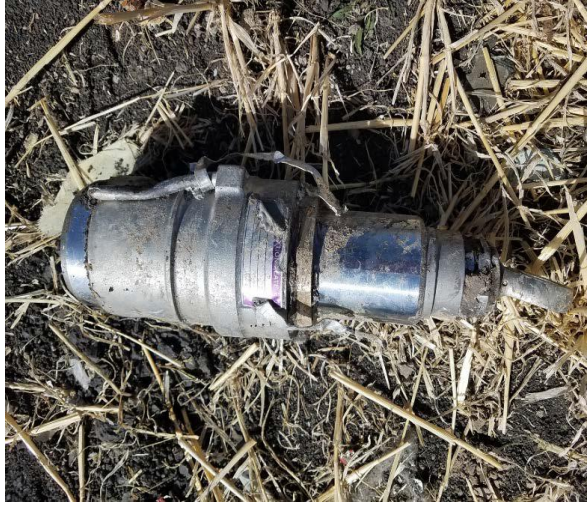
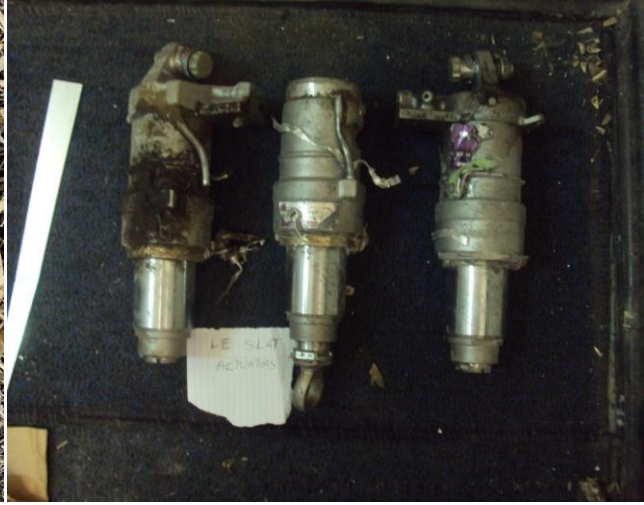
Two of the 8 leading edge slat actuators were photographed (see Figures below) at the impact site. The installed location for each actuator has not been identified. The actuator position, as photographed, is in the fully retracted position.

During the examination of the wreckage pile located at the Addis Ababa airport AIB store the Airworthiness group identified a total of three leading edge slat actuators at the impact site. The actuator position, as photographed, are in the fully retracted position,

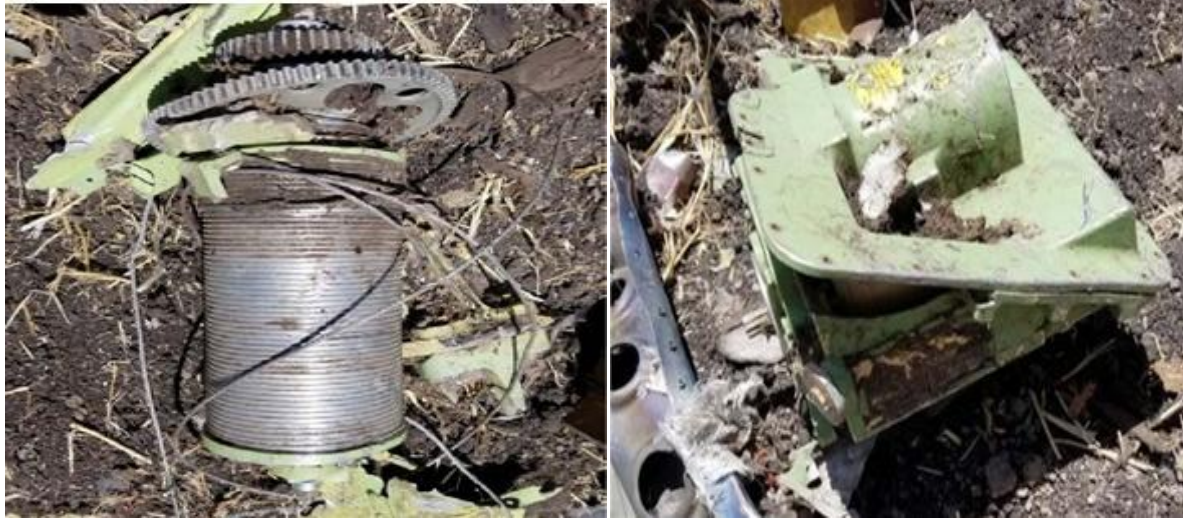
Two parts of the control system were located and examined at the impact site. One consists of aft cable drum; the other consists of the stab trim actuator (see Figures below respectively). These components do not provide any evidence of what position the horizontal stabilizer may have been at the time of impact.

Most of the located components of the stabilizer trim system were located once the wreckage was transported to Bole International Airport. The only part of the stab trim system located on site was the motor housing (see above). Referencing figure 51 above, the parts located in the wreckage pile at the airport consisted of the Primary Brake Housing (has the Lower Gimbal on it), the entire jackscrew (fractured into three pieces), and the ballnut (jammed onto the screw). The damage to the components of the stabilizer trim system is consistent with a high energy impact.

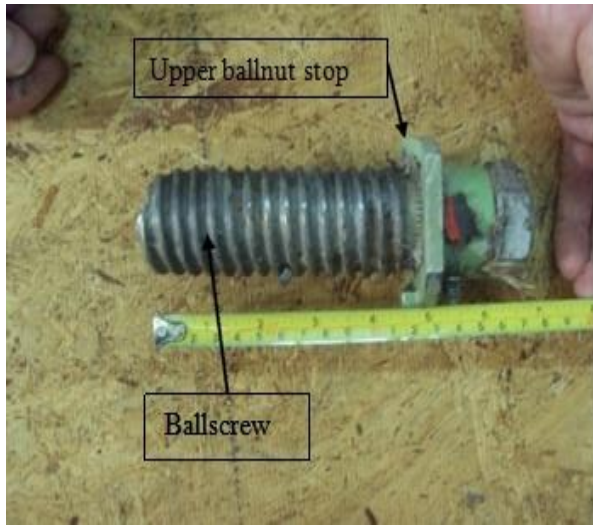
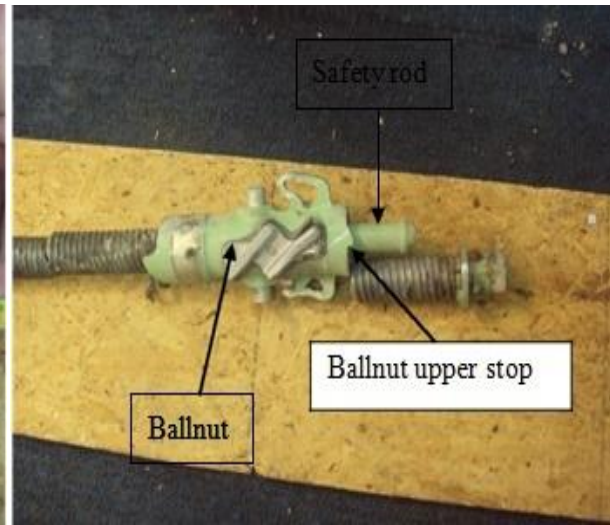
Examining the fracture surfaces, the upper screw segment fits with the fracture face just inside the ballnut giving a measurement between the stops on the ballnut and the upper ballnut stop of ~5". Referencing Boeing document D251A122 (737NG Control Position Data), this measurement equates to a stabilizer trim setting of 1.5 degrees Airplane Nose Down (AND) or an indicated position of 2.5 units of trim. Although the data is for the 737NG, the position of the MAX stab trim holds the same relationship. According to Boeing:

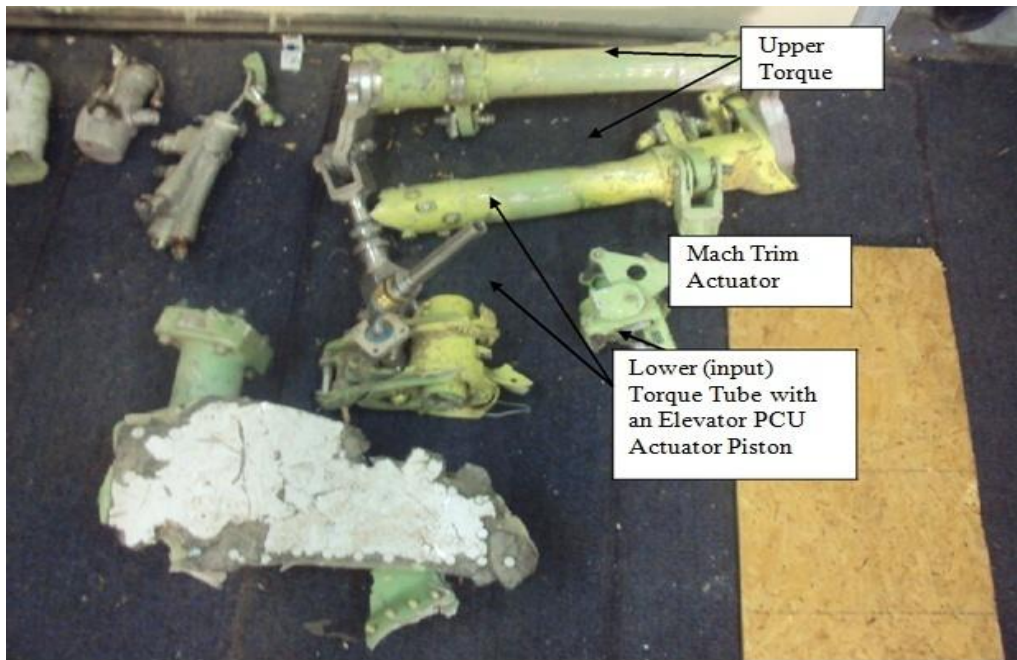
FIGURE55: ELEVATOR PCU ACTUATOR PISTON

The only components that were located for this system were the output torque tube, the mach trim actuator, a small portion of the Elevator feel and centering unit, and a small piece of the elevator input torque tube. The Figure 55 above shows the recovered components of the elevator control system. Note that all components, like the lateral components show significant

damage consistent with a high-energy impact. The upper torque tube was fractured in half. Only a small portion of the lower (input) torque tube was recovered along with a piston of the Elevator Power Control Unit actuator. The Mach Trim Actuator was found in the fully retracted position.

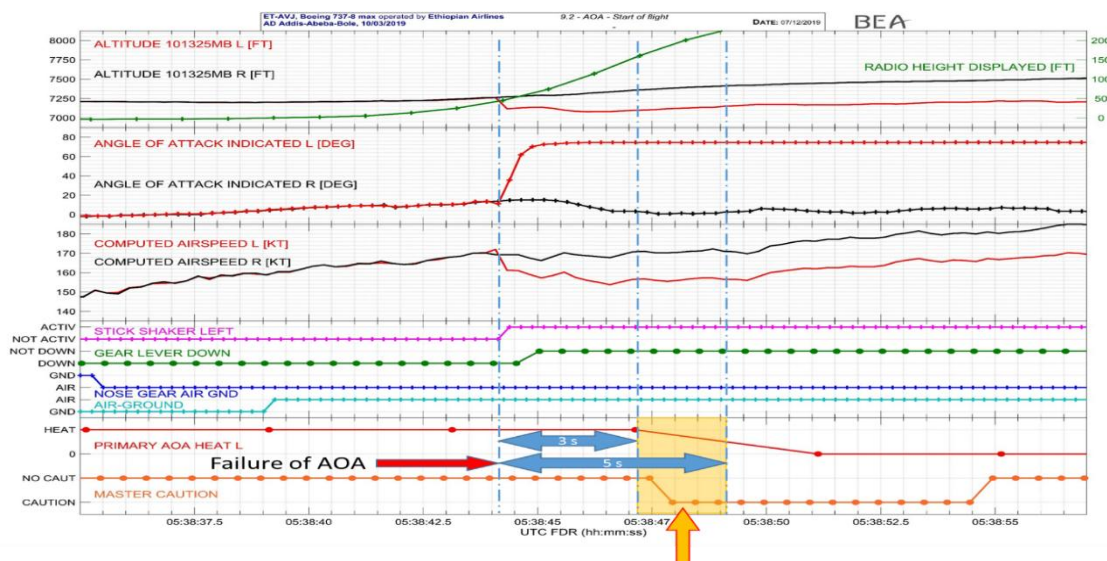
FIGURE 56:

AOA VALUES DURING THE BEGINNING OF THE FLIGHT

The recorded computed airspeed values and the recorded corrected pressure altitude values were computed with the signal coming from the AOA sensor resolver No2. Their values were consistent with the shape of the LH AOA recorded values (for both parameters, an increase followed by a decrease). The triggering of the stick shaker underlined that the signal coming from the resolverNo1 matched also the LH AOA recorded values. Due to the way the AOA values were recorded, both resolvers of LH AOA sensor provided similar values. The failure impacted the signals provided by both resolvers of the LH AOA sensor.

According to the description provided in §1.6.3.3 it took between 3 to 5 s between the AOA heat failure and the triggering of the associated master caution. The LH AOA heat failure triggered at a time consistent with a single event leading to both heat failure and erroneous values from both resolvers at the same time.

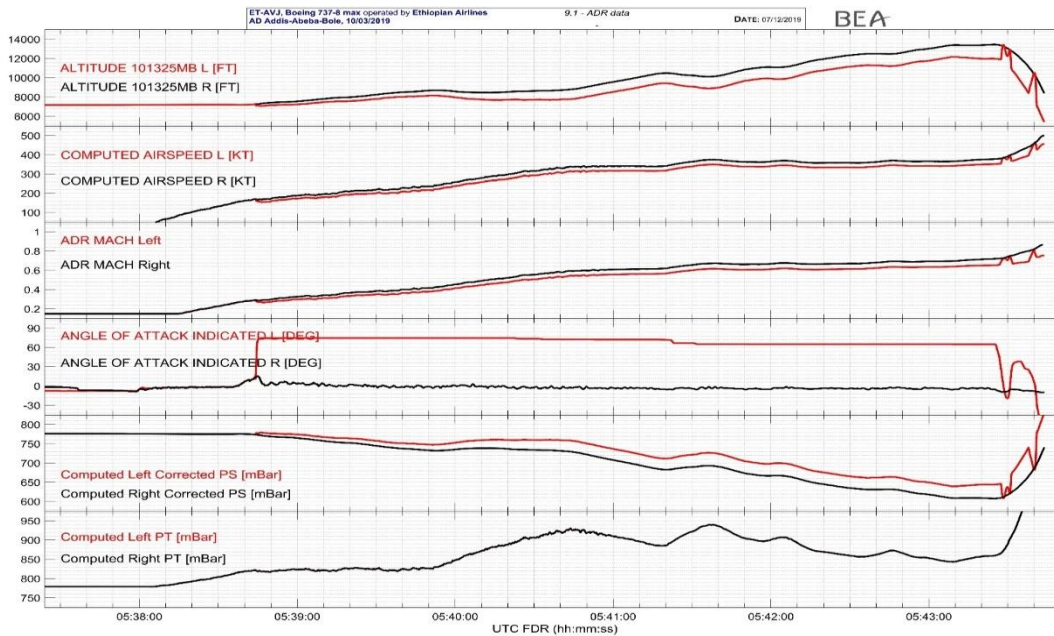
FIGURE 57: AIR DATA PARAMETERS

During the flight of the event, the recorded altitude values, the recorded CAS values and the recorded Mach numbers diverged after LH and RH AOA values divergence.

The RH and LH computed total pressure values were identical. The difference between the recorded Mach number and between the recorded computed airspeed values were due to the difference of the corrected static pressure values.

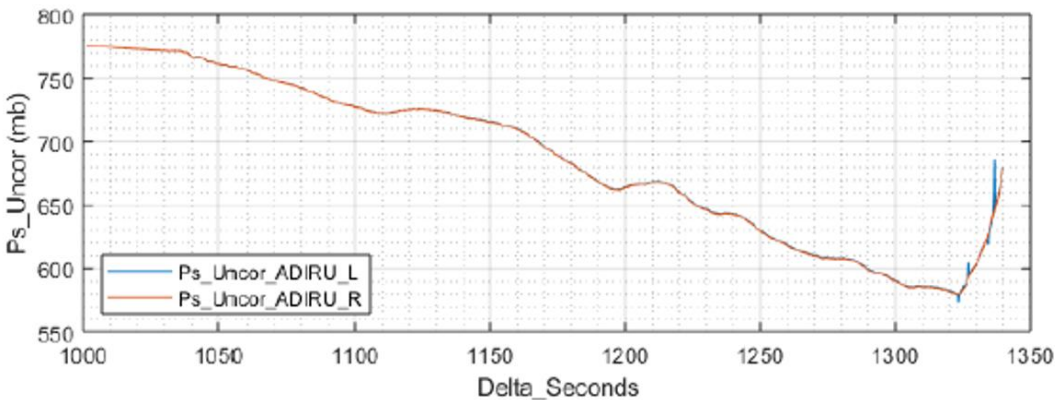
FIGURE 58: UNCORRECTED STATIC PRESSURE COMPUTED BY THE AIRPLANE MANUFACTURER

Uncorrected static pressure values from both sides were identical. The difference between the LH and RH side corrected pressure values were therefore only due to the AOA correction.

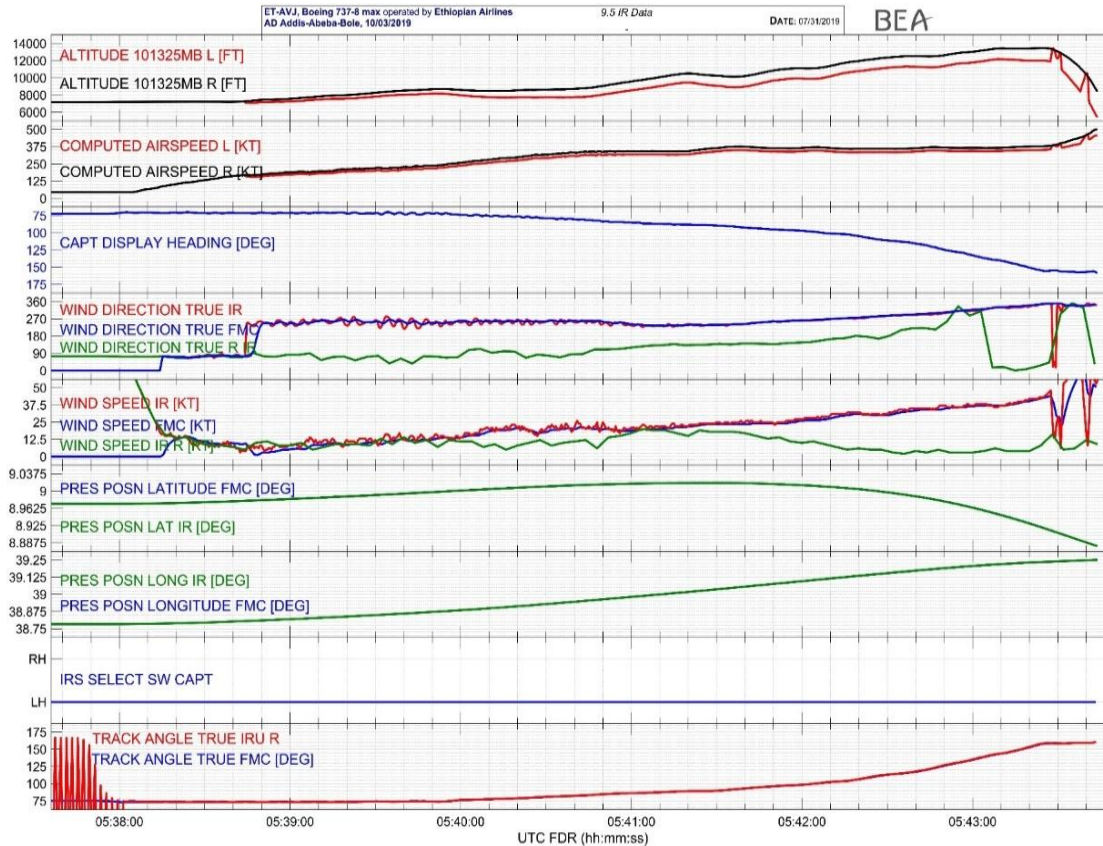
FIGURE 59: IMPACT OF AOA FAILURE ON THE WIND COMPUTED VALUES

Most of the recorded IRS parameters did not show any variation following the AOA failure. On the contrary, the computed wind, on the left side, was clearly affected by that failure.

The LH IRS was selected for the flight of the event. The invalid wind computed values impacted also the FMC that smoothed the values coming from the selected IRS.

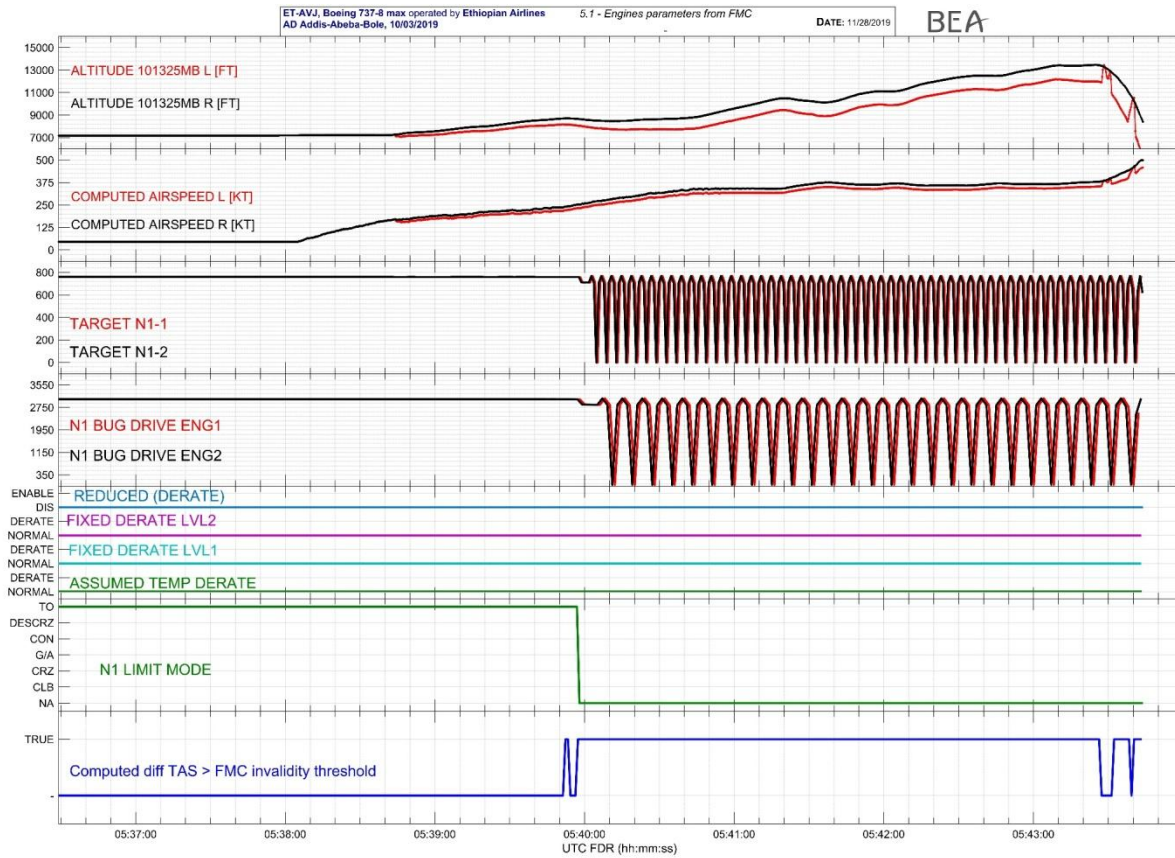
FIGURE60: FMC PARAMETERS FOR THE ENGINES

Note: At 5 h 39 min 52 s, the difference between the computed LH and RH TAS values reached the threshold value used by FMC to detect inconsistency. Whatever the impact of these 2 samples might have had, no information of invalidity can be recorded inside the FDR recorded data.

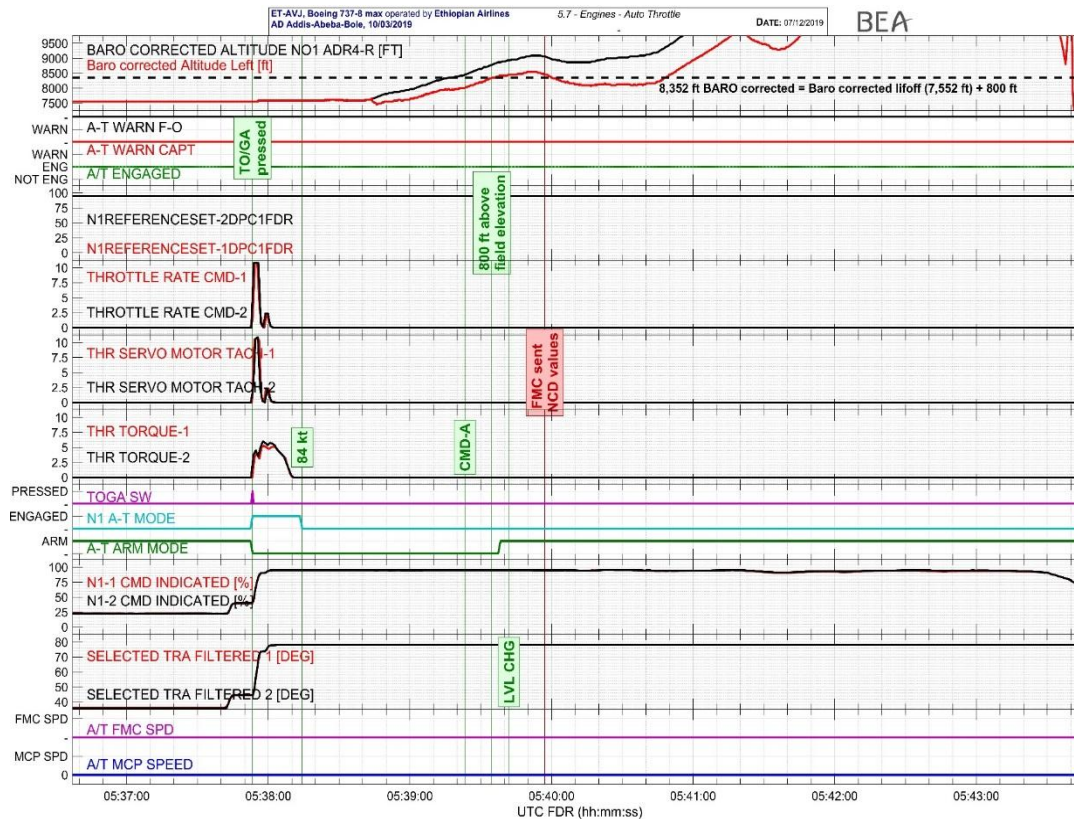
FIGURE 62: AUTO THROTTLE BEHAVIOR DURING THE FLIGHT OF THE EVENT

- At 05 h 37 min 53 s, the TO/GA switch was pushed. A/T switched to the N1 mode. The automatic takeoff and climb was engaged. A/T moved automatically the throttles forward (*THROTTLE RATE CMD-[1/2]* values, *THR TORQUE-[1/2]* values were positive). TRA did not move anymore until the end of the flight because the FMC used the LH baro corrected

altitude values, which were lower than the true ones. Thus, FMC did not detect the thrust reduction altitude when it was sending valid engine commands. And LH and RH TAS diverged by more than 25 kts the FMC did not send any valid N1 target values

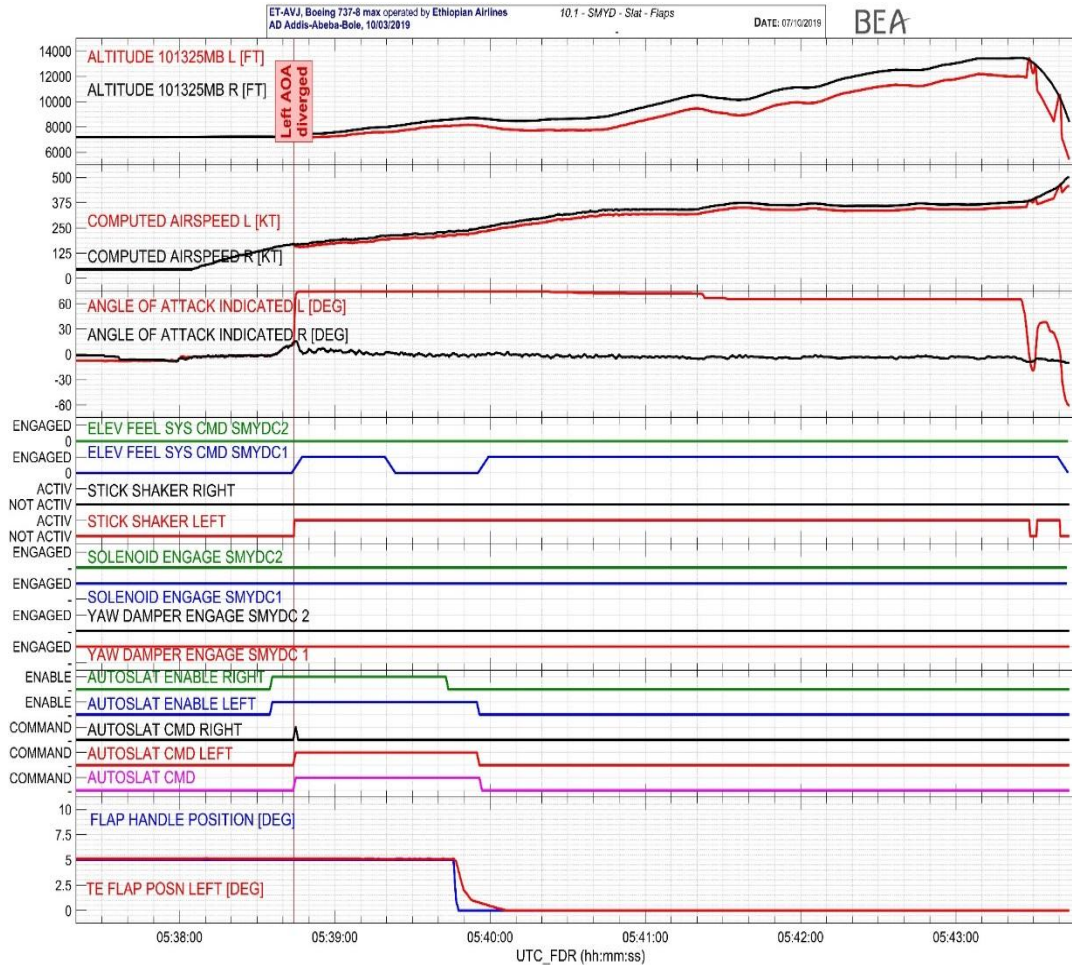
FIGURE63: AUTOSLAT, LEFT STICK SHAKER AND ELEVATOR FEEL SYSTEM

At 5 h 39 min 56 s, the autoslat system stopped and the flap handle was at 0 position and flaps were moving up (flaps position lower than 1) with LH computed airspeed values reaching 230kt and RH computed airspeed value 250kt.

At 5h 39 min 44s SMYDC-2 disabled the RH autoslat function due to the RH computed airspeed (230kt reached). SMYDC1 disabled the LH autoslat function 12 s later due to the invalid LH computed airspeed.

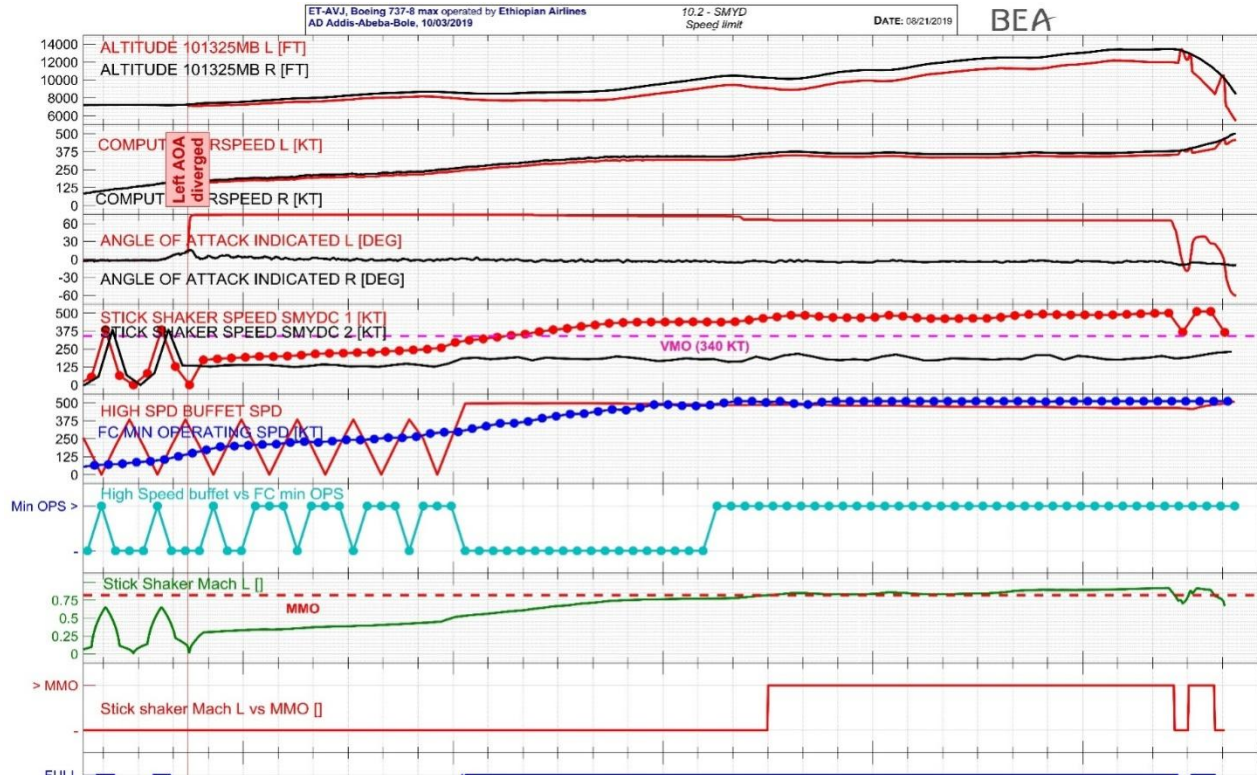
FIGURE 64: SMYD COMPUTED SPEEDS LIMITS

At 5 h 41 min 17 s, SMYDC1 computed FC minimum operational speed values greater than High speed values. Both values were computed by the same computer SMYDC 1.

The speed tape of the airplane had a range of 120kt (60kt above and below the actual computed airspeed). As soon as the stick shaker speed reached values higher than the actual computed airspeed plus 60kt, red and black stripes are displayed all along the border of the speed tape.

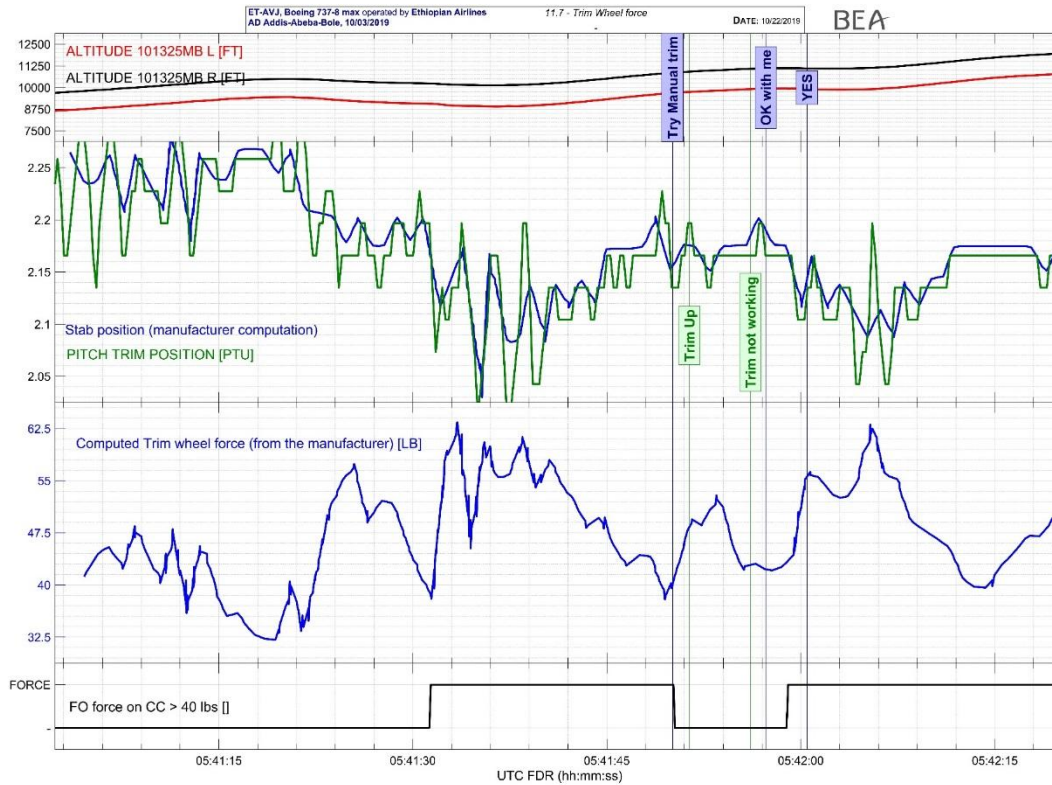
FIGURE 66: FORCE NEEDED TO MOVE THE TRIM WHEEL

By the time the FO tried to move the trim wheel manually a force between 42 lbs and 53 lbs was required according to the aircraft manufacturer computation, (see Figure 6).

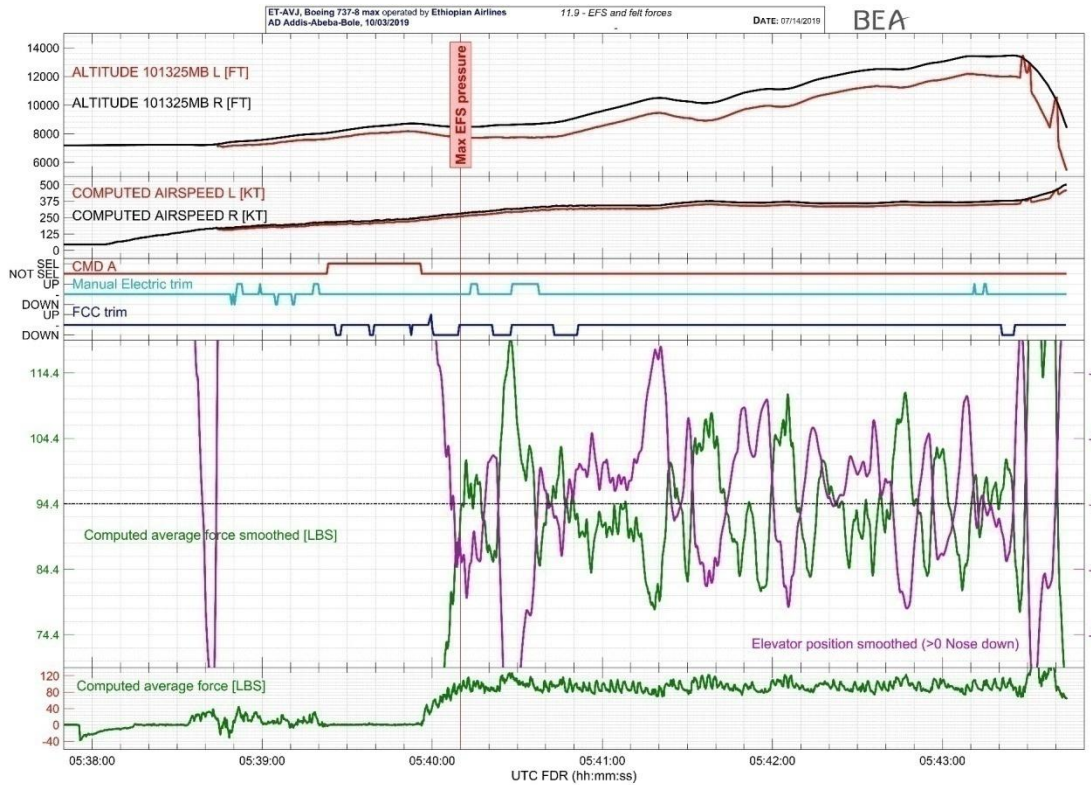
FIGURE 68: FELT FORCE AND ELEVATOR POSITION

Before the A/P engagement, the recorded low force level underlined an airplane rather properly trimmed in pitch. At that time, the stabilizer position was 5.62 units (nose up setting) and the elevators position was of 3.5° (nose down setting).

The gradient of force felt by the crew can be illustrated by the comparison between the force applied on the control column and the position of the elevator.

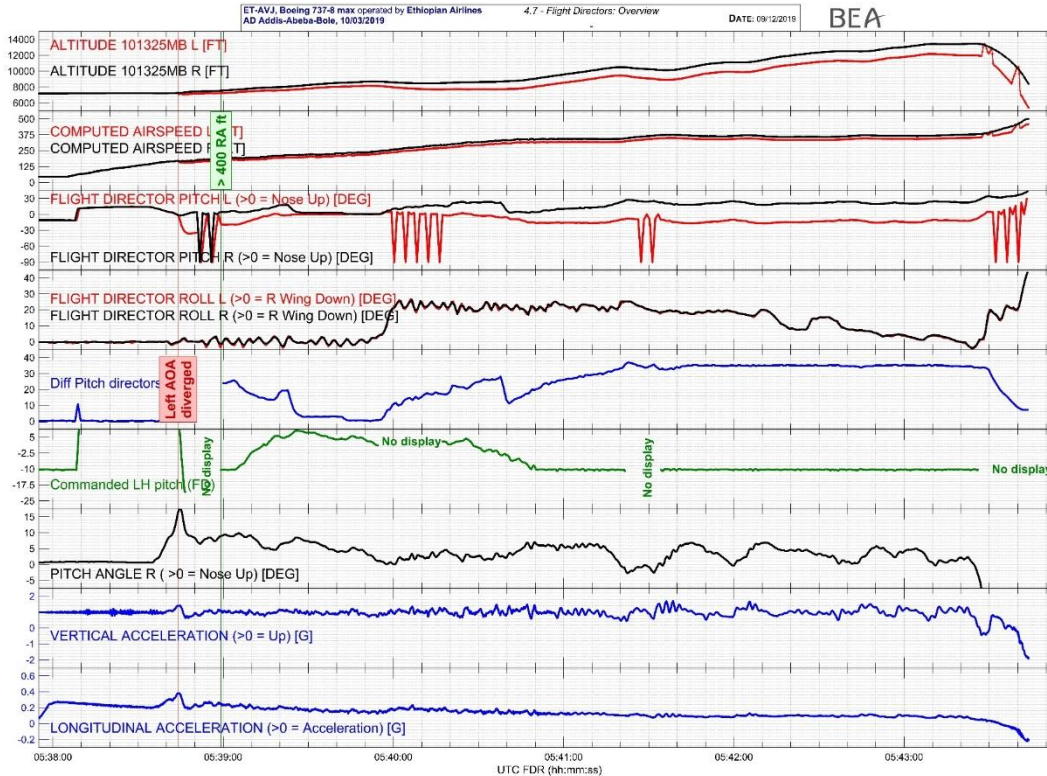
FIGURE 69: FLIGHT DIRECTOR DURING THE FLIGHT

Each time the LH or the RH invalidity pattern was recorded, the recorded invalidity code (NCD - No Computed Data) underlined a pitch F/D bar biased out of view.

Note: as the invalidity code was always NCD, the pitch command bar was only BOV. F/D flag did not trigger during the whole flight of the event.

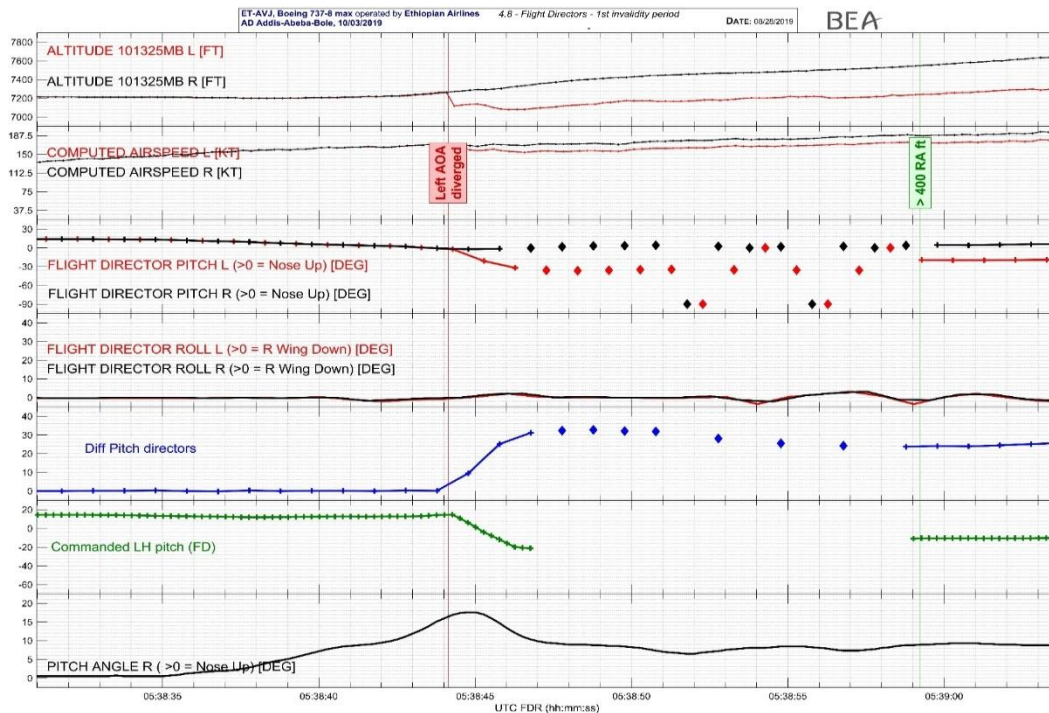
FIGURE 70: FLIGHT DIRECTORS - START OF THE FLIGHT

When the LH and RH AOA values diverged, LH pitch F/D commands recorded values quickly decreased to -32° while RH pitch F/D recorded values slightly increased to -0.4° . The difference between LH pitch F/D values and RH pitch F/D values were greater than the threshold above which FCCs comparators triggers and both F/D pitch were biased out of view.
