Aircraft Accident Investigation Bureau

Interim Investigation Report on

**Accident to the B737-8 (MAX) Registered ET-AVJ operated by
Ethiopian Airlines**

Report No. AI-01/19

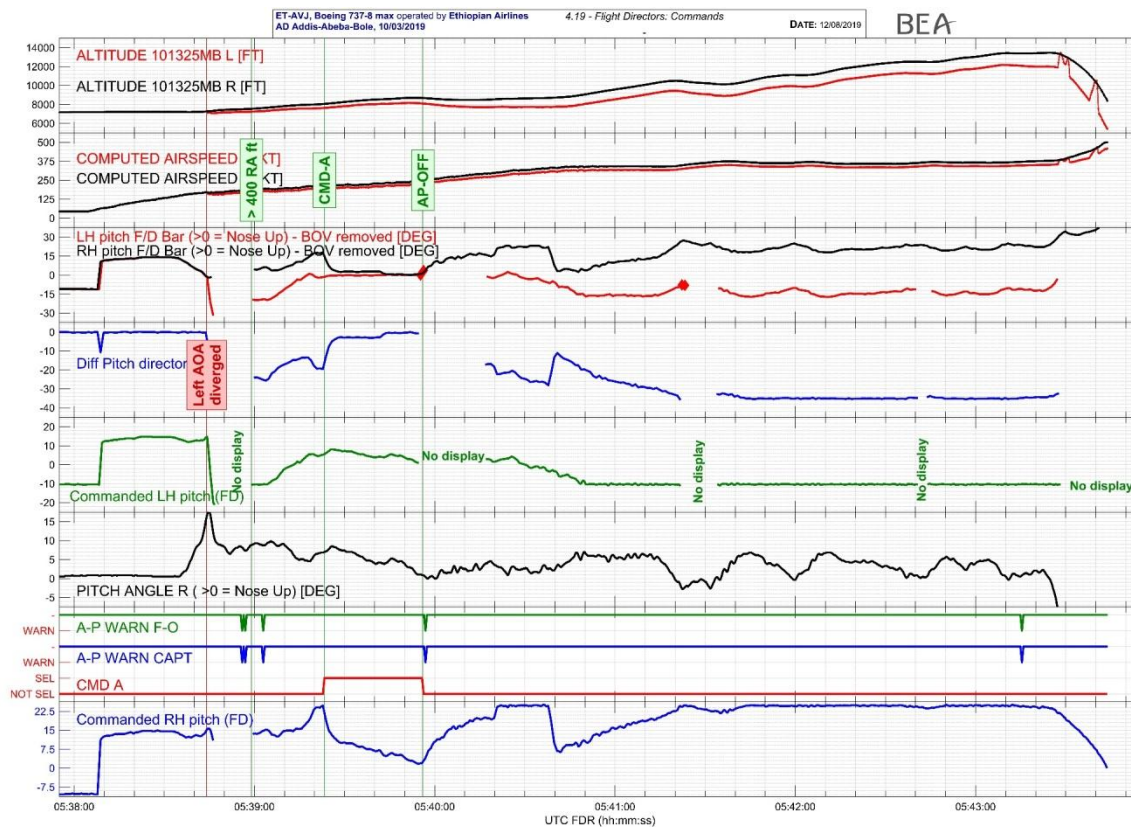
FIGURE71: PITCH F/D COMMANDS

Each invalidity period was due to the following conditions, described as an unsafe condition in the Aircraft Maintenance Manual:

- The F/D was in speed mode.
- The airplane should have been climbing but the computed vertical speed value of the airplane had been lower than the Climb Threshold for 5 consecutive seconds.
- At the LH side the airplane approached to stall

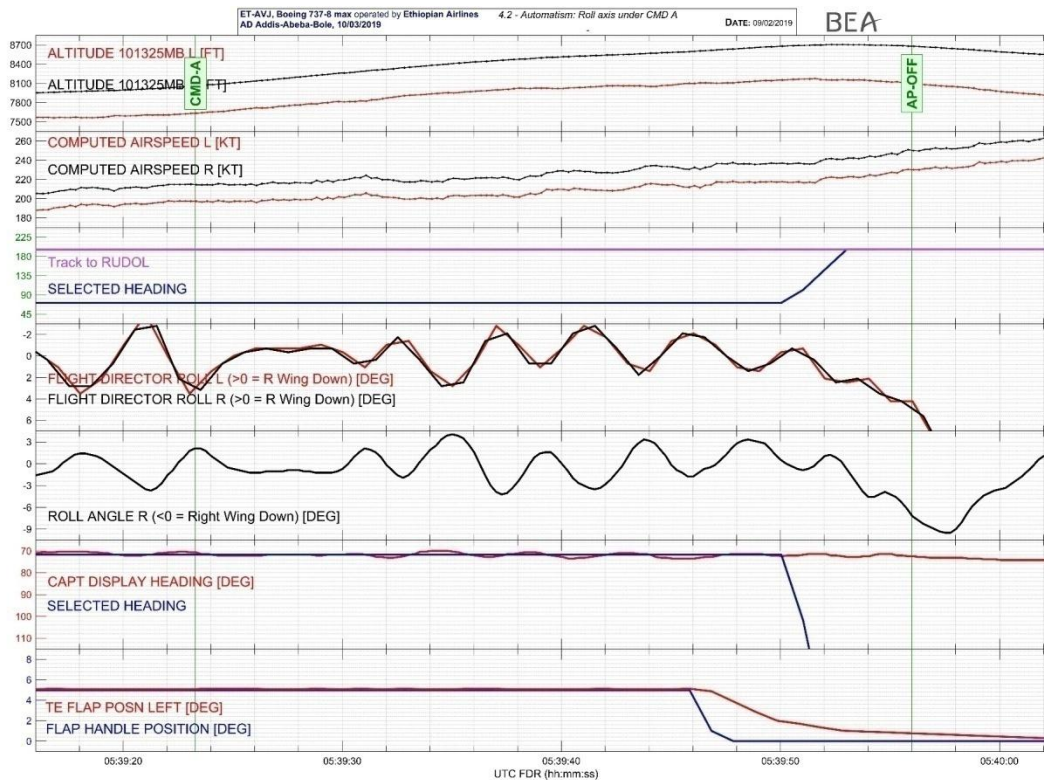
FIGURE 72: ROLL AXIS UNDER CMD A

The roll axis under CMD A behaved as expected:

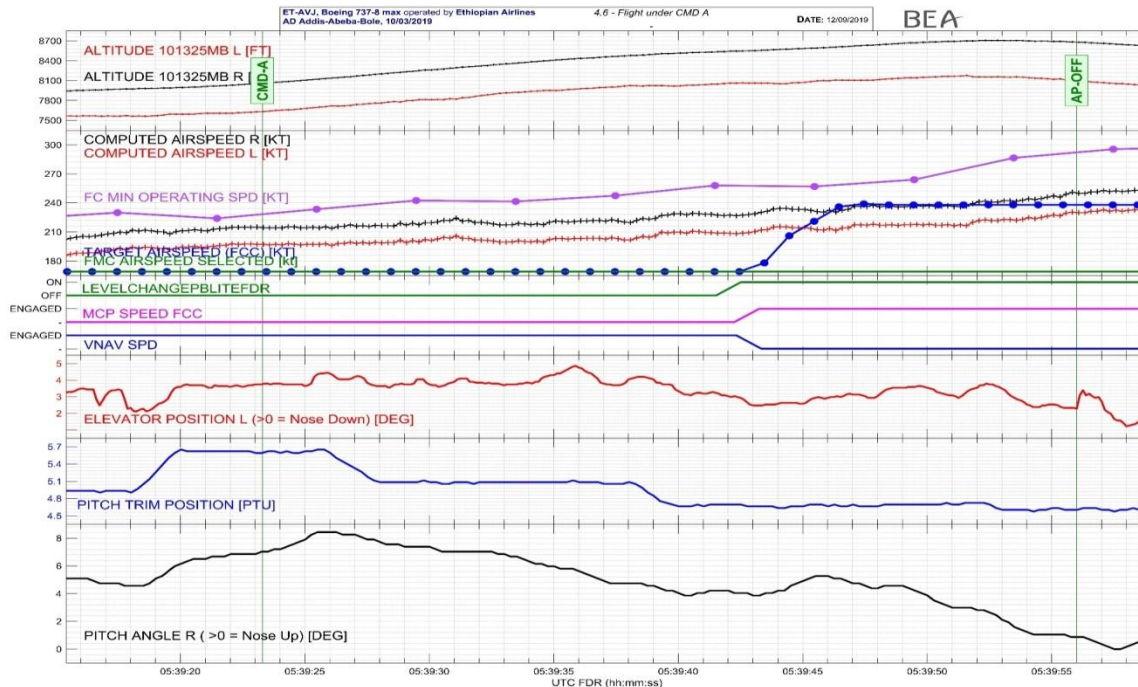
FIGURE 73: CMD A ENGAGEMENT

The longitudinal engaged mode (VNAV SPD) is a speed mode.

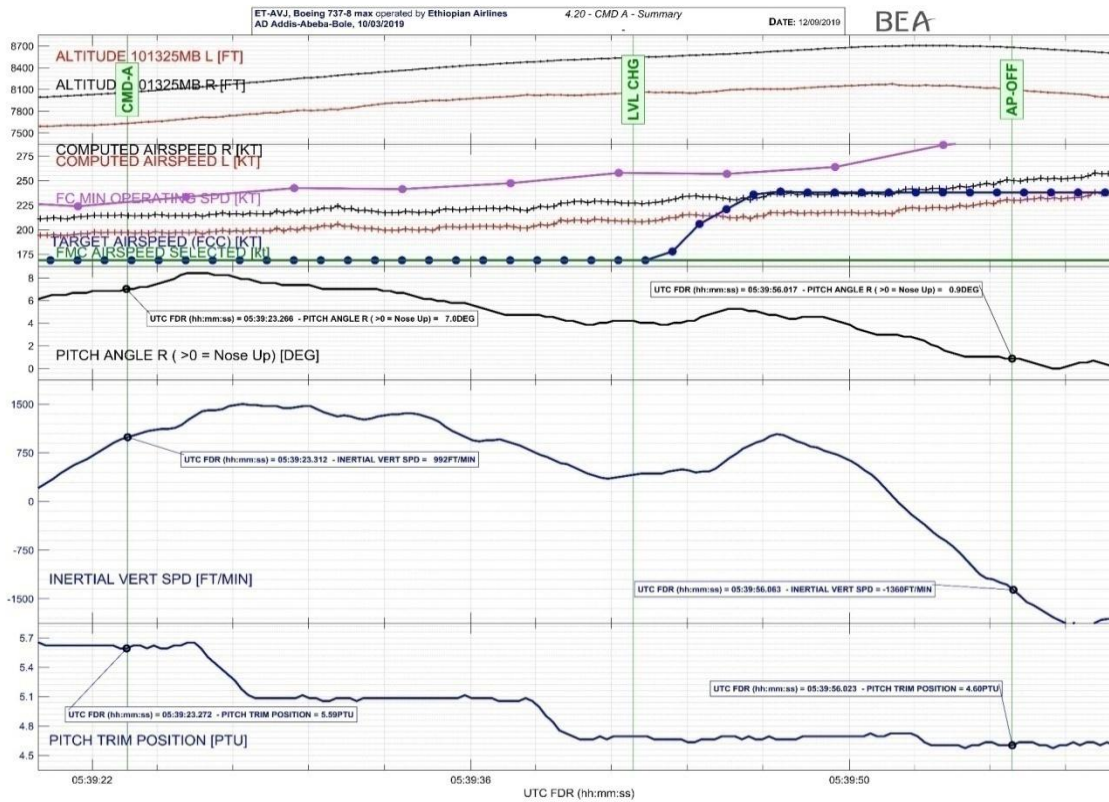
FIGURE74: CMD A - SUMMARY

At the connection of CMD A, the airplane was climbing with a vertical speed of around 1,000 ft/min increasing, a pitch value of around 7° increasing and a stabilizer position of 5.6 units.

When CMD A automatically disconnected, the airplane was descending with a vertical speed of around -1,400 ft/min, a pitch angle of around 1° and a stabilizer position of 4.6 units.

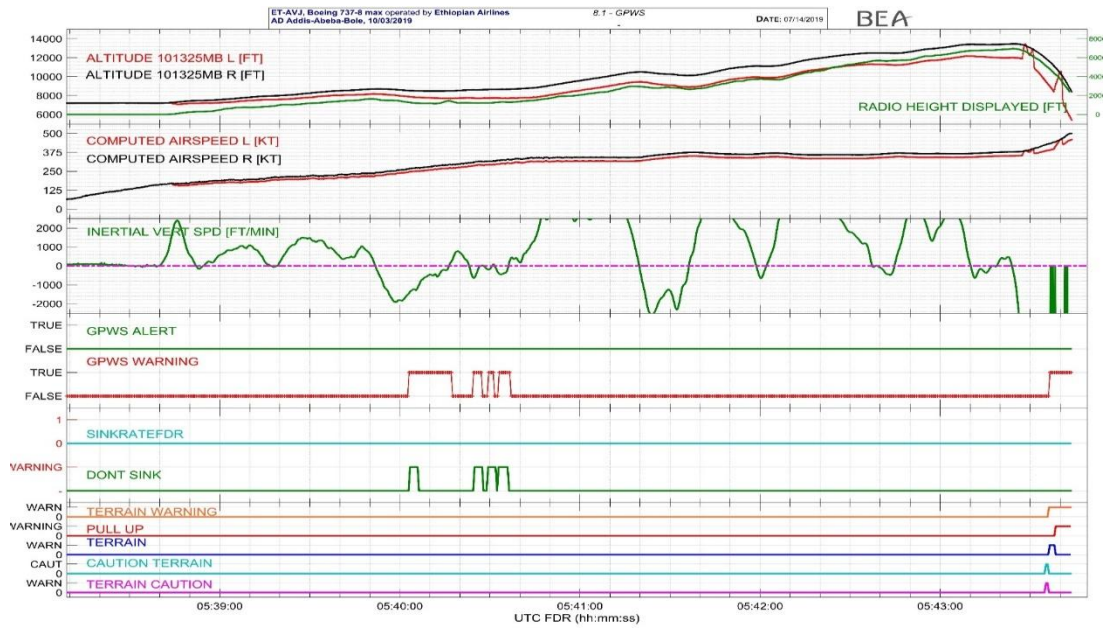
FIGURE 76: GPWS ALERTS

At the end of the flight, the combination of the vertical speed and the height of the airplane made the terrain and pull up warning trigger.

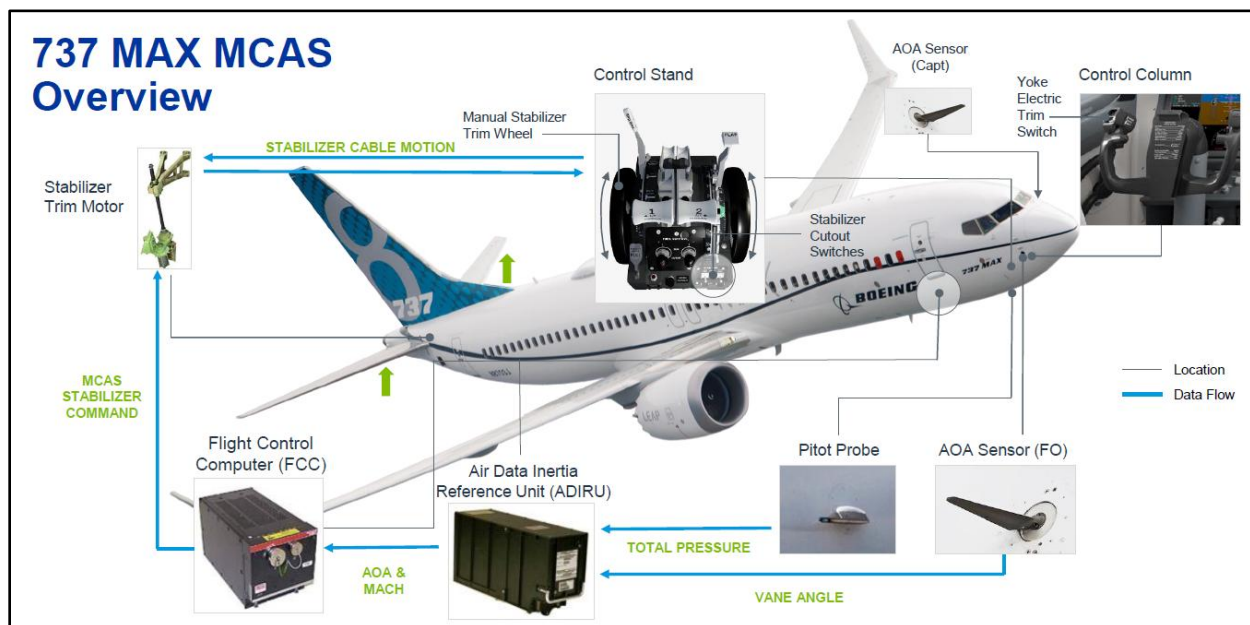
FIGURE 81: MCAS OVERVIEW

As originally delivered, the MCAS became active during manual, flaps-up flight (autopilot not engaged) when the AOA value received by the master FCC exceeded a threshold based on Mach number. When activated, the MCAS provided a high rate automatic trim command to move the stabilizer AND. The magnitude of the AND command was based on the AOA and the Mach. After the non-normal maneuver that resulted in the high AOA, and once the AOA fell below a reset threshold, MCAS would move the stabilizer ANU to the original position and reset the system. At any time, the stabilizer inputs could be stopped or reversed by the pilots using their yoke-mounted electric stabilizer trim switches, which also reset the system after a 5 second delay.

The latter behavior is based on the assumption that flight crews use the trim switches to completely return the airplane to neutral trim. In the FCC software version current at the time of the accident, if the original elevated AOA condition persists for more than five seconds following an MCAS flight control law reset, the MCAS flight control law will command another stabilizer nose down trim input (with the magnitude based on the AOA and Mach sensed at that time).
